The Value of Solution Selling

Torque Transmission, Fairport Harbor, OH – October 18, 2006

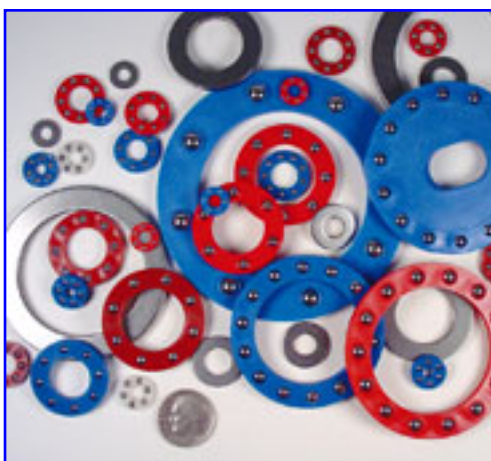
Torque Transmission non-standard OD/ID stainless steel metric thrust bearing.

- Nylon ball retainer, self-lubricated.
- 410 stainless steel balls.
- 440 stainless steel washers RC 58-65.
- Non-corrosive with many chemicals and solvents.

Kloehn Ltd., a manufacturer of Analytical, Clinical, and Industrial Diagnostic Instrumentation, was experiencing product failures in a pump sub-assembly due to bearing corrosion. The thrust bearing at fault was very small (9mm OD / 4mm ID), difficult to source, and expensive.

An offshore supplier was providing a bearing that was dimensionally correct but used a coated, carbon steel washer. The coating was susceptible to wear, resulting in failure due to corrosion. In a product for the medical field this was unacceptable for the end-user and our customer.
